## **Evaluation of Faun MLC-70 Trackway Mat System Under Simulated F-15 Traffic**

Timothy W. Rushing, Lyan Garcia, and Quint S. Mason

May 2014

Final report

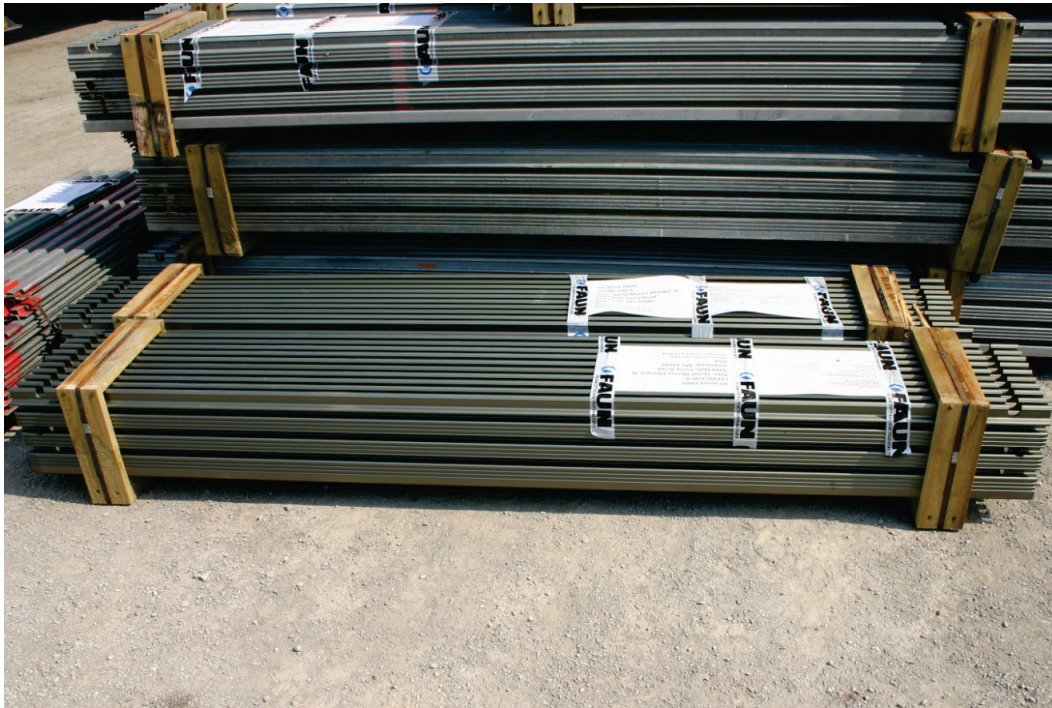
Figure 4. MLC-70 Trackway panels.

The MLC-70 Trackway matting system was developed in the 1960s to create temporary roadways for heavy military vehicles used by the United Kingdom Ministry of Defence. MLC-70 panels, shown in Figures 4 and 5, are made from a single aluminum extrusion. When the panels are assembled in an array, they can be rolled up for storage and transportation.

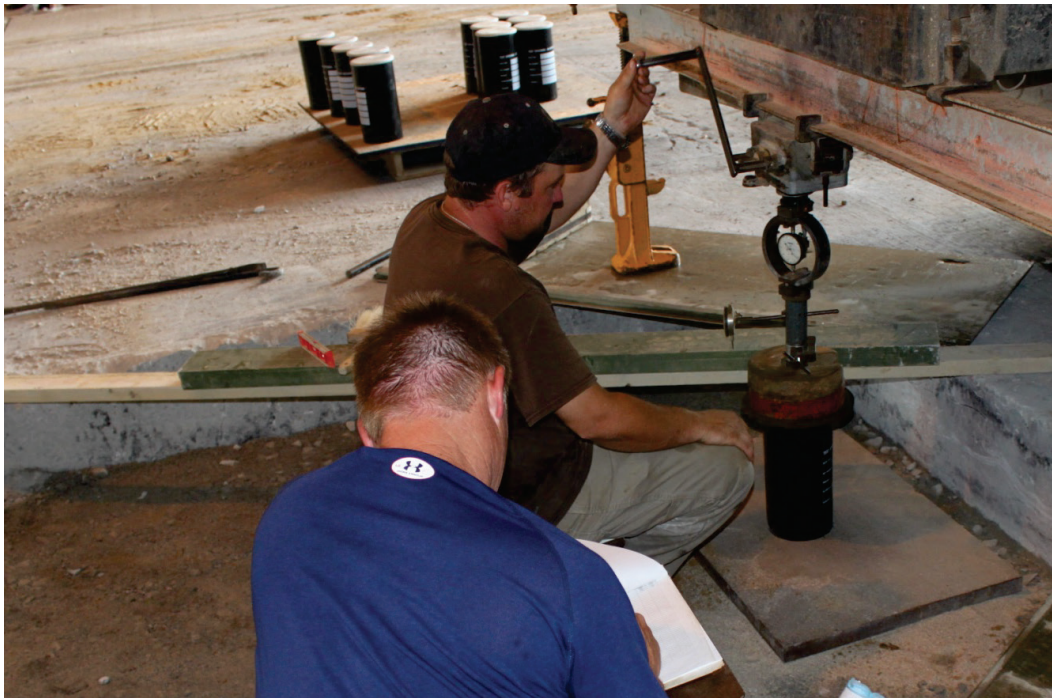
Figure 8. Conducting field CBR test in 6-in. cylinder molds.

In situ field CBR tests conducted on the existing CL soil at the outdoor test site chosen for test section construction found strengths on the soil surface ranging from 4 to 12 CBR. To achieve the desired 20 to 40 CBR strength, cement stabilization of the upper 8 in. of the existing soil was required. To determine the cement content needed to achieve the desired strength, a stabilized soil mix design was performed using 3%, 5%, and 7% cement, by volume, added to the CL material with 12% optimum water content. Samples were prepared by mixing the soil and cement in a portable concrete mixer and compacting the samples in 6-in.-diam by 12-in.-deep concrete cylinder molds. Field CBR tests were conducted after a 24-hr cure time in the cylinders, as shown in Figure 8, to determine their representative strengths. Based on the test results, 5% cement was adequate to obtain a 20-40 CBR subgrade. The 30-ft-wide by 40-ft-long test section was

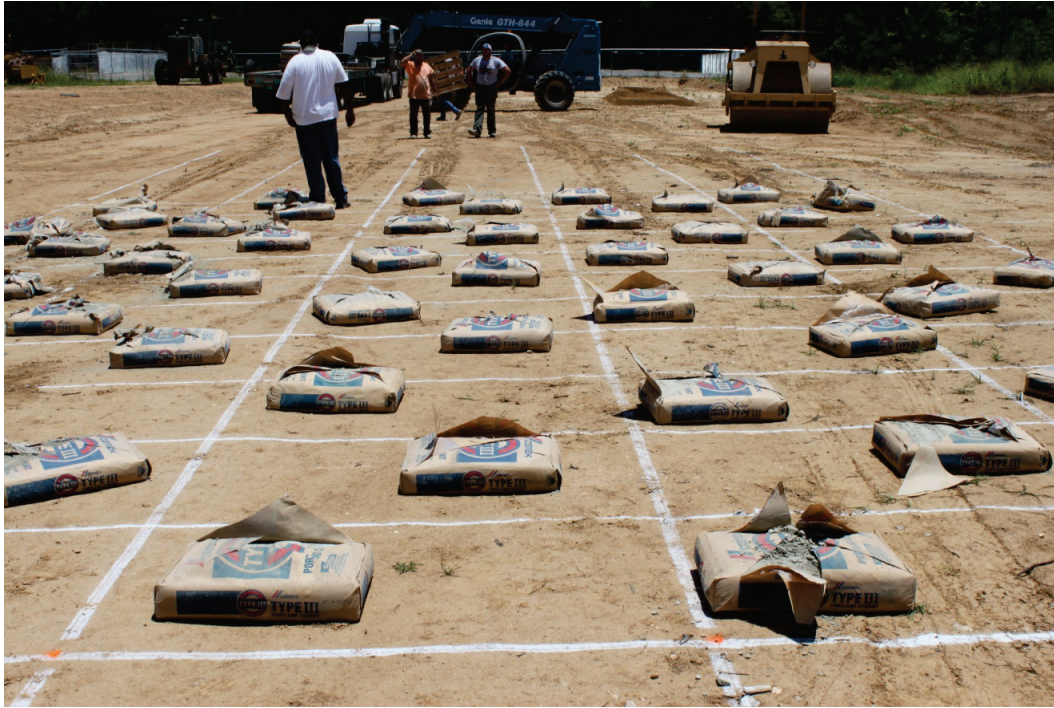
Figure 9. Cement bags placed in grid area prior to spreading.

stabilized by mixing 80 bags of type III cement into the top 8 in. of existing soil with a Terex reclaimer/stabilizer. The test section area was divided into a grid based on the soil volumetric measurements such that one 80-lbf bag of cement spread over the area inside a grid square and mixed 8 in. deep would result in 5% cement. After the bags were placed, as shown in Figure 9 and spread inside each grid, additional cement was added along the approach lane of the stabilizer to ensure the cement inside the test area was consistent and not dragged outside the test area. Then the cement was thoroughly mixed with the soil, as shown in Figure 10, and the test section was compacted with three coverages of a vibratory steel wheel compactor, as shown in Figure 11.

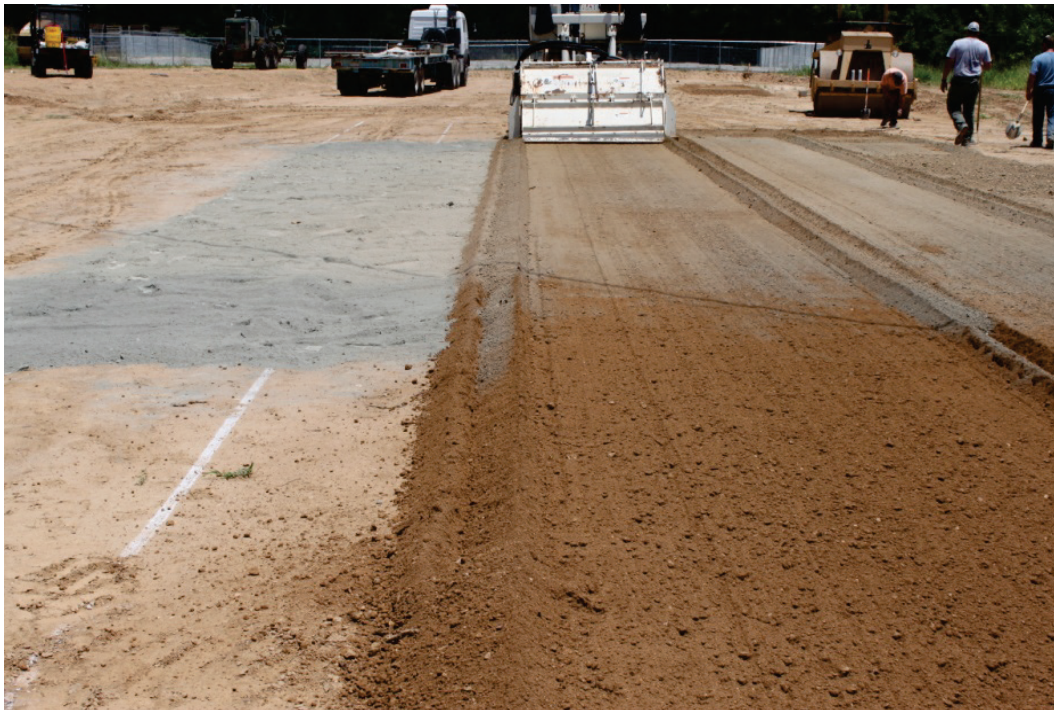
Figure 10. Mixing cement into the soil with a reclaimer/mixer.

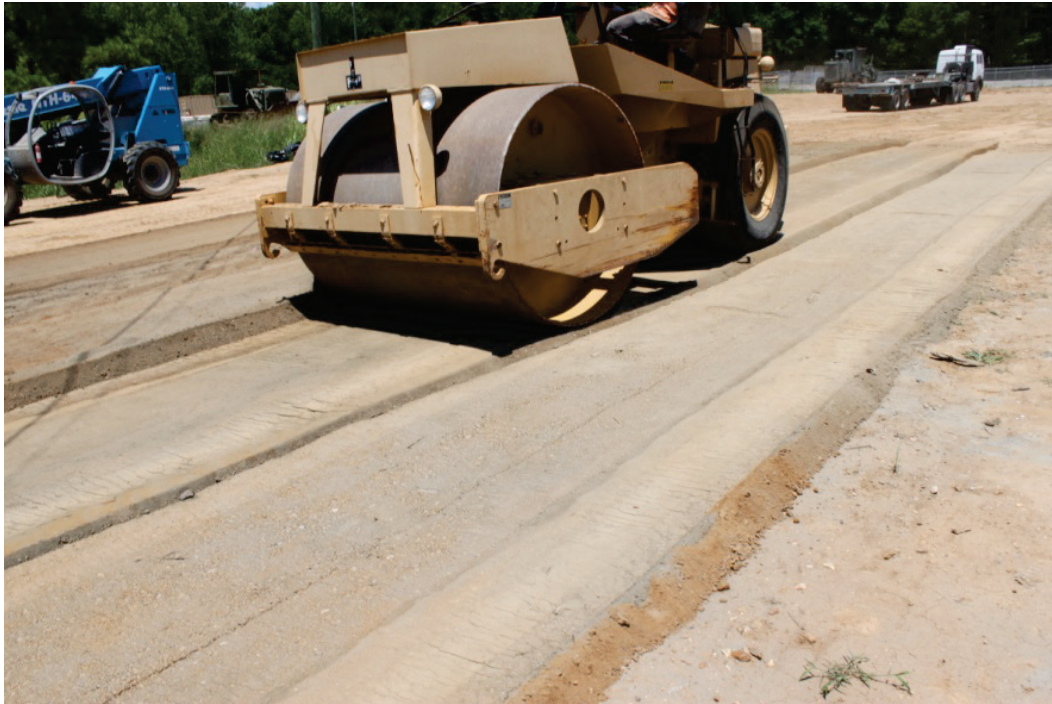
Figure 11. Compacting stabilized subgrade with vibratory steel wheel roller.

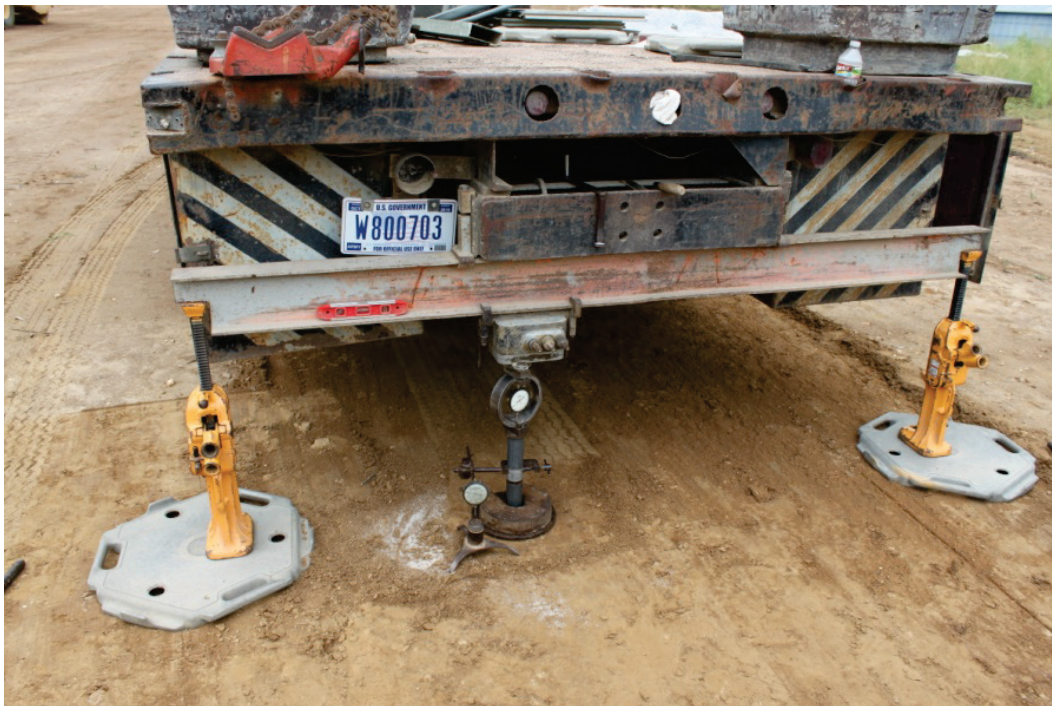
Figure 12. Field CBR test.

After 24 hr of cure time, field CBR, as shown in Figure 12, and dynamic cone penetrometer (DCP) tests were conducted, according to ASTM D6951, on the test section at three quarter-point locations (10, 20, and 30 ft from the leading edge) along the length of the test section. The DCP tests were conducted to compare values to the field CBRs and to determine the strength profile and approximate thickness of the stabilized layer. The field CBR method could measure only bearing capacity of the surface without disturbing the stabilized material below. Perpendicular lines labeled A1, A2, and A3 were painted on the subgrade to mark the prescribed data collection locations as shown in Figure 1. Along A1, the

field CBR tests yielded values of 23, 26, and 25 CBR, and a single DCP reading showed approximately 50 CBR for the upper 5-in. soil layer. Along A2, field CBR values were 31, 35, and 33 CBR, and the DCP showed a

strength of approximately 60 CBR in the upper 5-in. layer. Along A3, field CBR values were 32, 31, and 30 CBR, and the DCP indicated approximately 35 CBR in the upper 5-in. layer. Based on these values, researchers determined that the CBR of the section generally fell within the desired 25-50 CBR range near the surface, although there was significant variability.

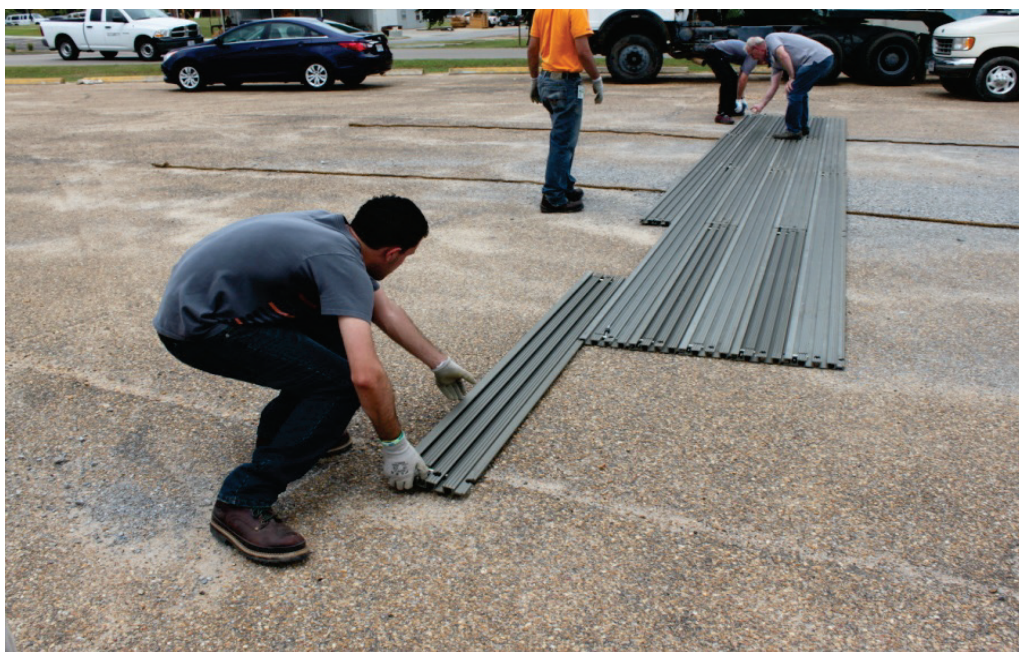
Figure 13. MLC-70 panel assembly.

with half-panels inserted on each end of every other row. First, a full MLC-70 panel was placed along the baseline in the southwest corner of the assembly area. Subsequent rows were attached by inserting the male edge of the mat into the female edge of an existing mat and then sliding the panels together along their entire length while flat on the ground surface. No connection system was required on the short ends of the panels, so the system could be assembled from both sides of the installation area concurrently. Panels had to be “slid” across a maximum of only 15 ft of the area to complete assembly. Once panels were in position, shoot bolts were inserted into supplied notches in the male connector edges to prevent lateral movement of panels in each row. Figures 13 and 14 illustrate how the matting system was assembled. Once assembly was complete, the finished matting system was rolled (Figure 15) and loaded on a truck (Figure 16) that carried it to the test site.

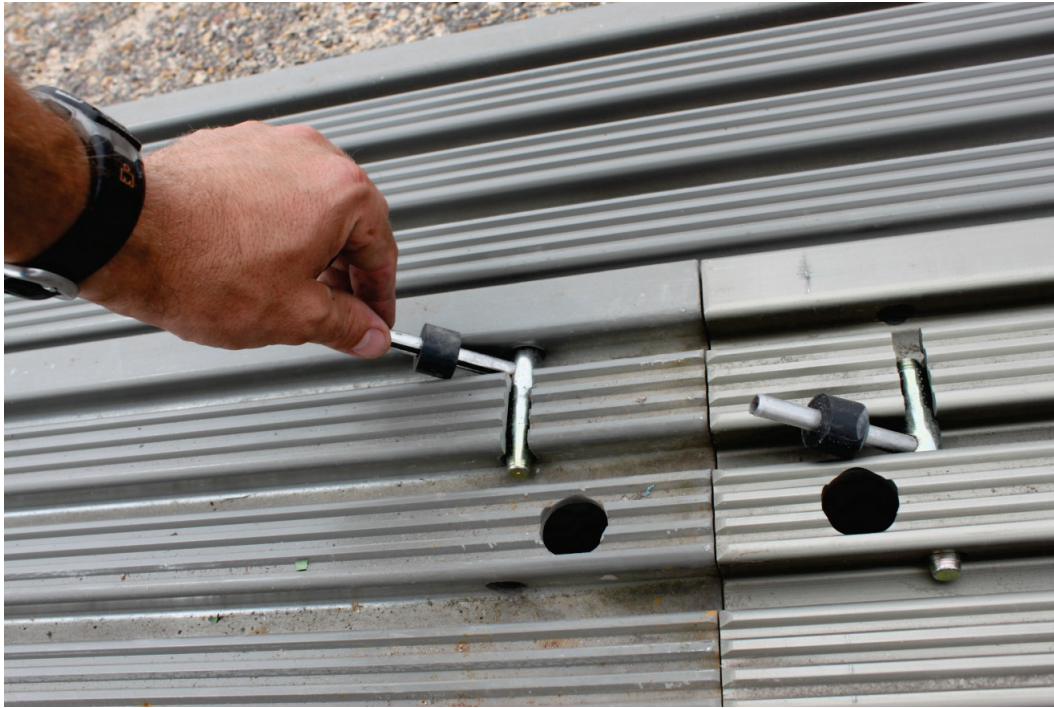
Figure 14. MLC-70 shoot bolt insertion.

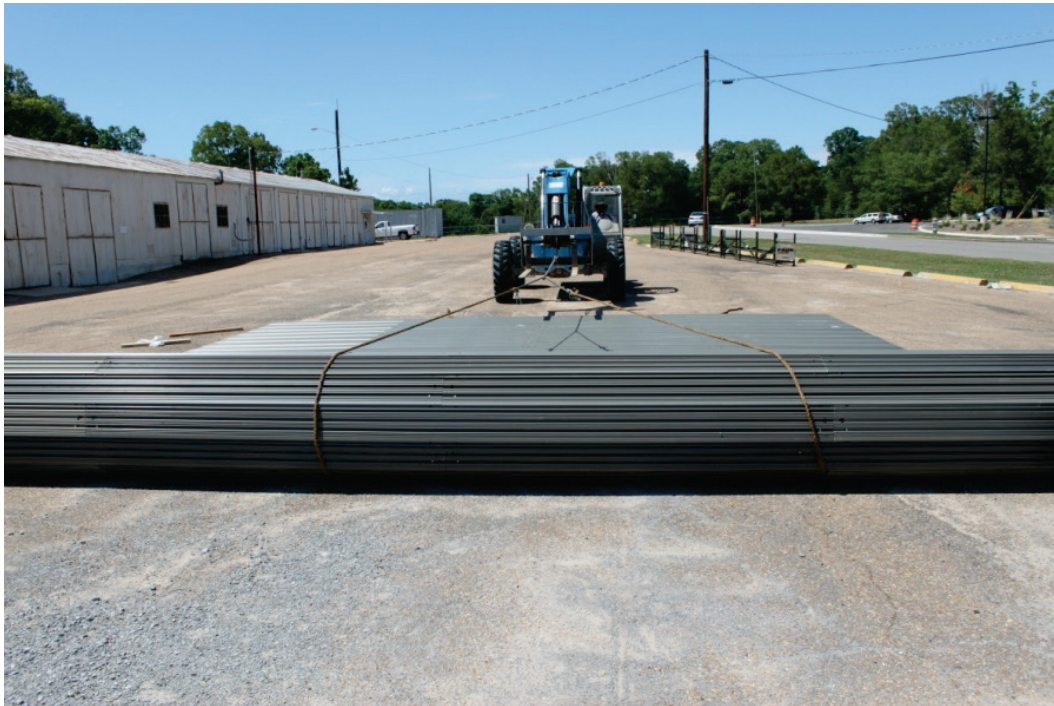
Figure 15. Rolling assembled mat expander for transportation to the test section.

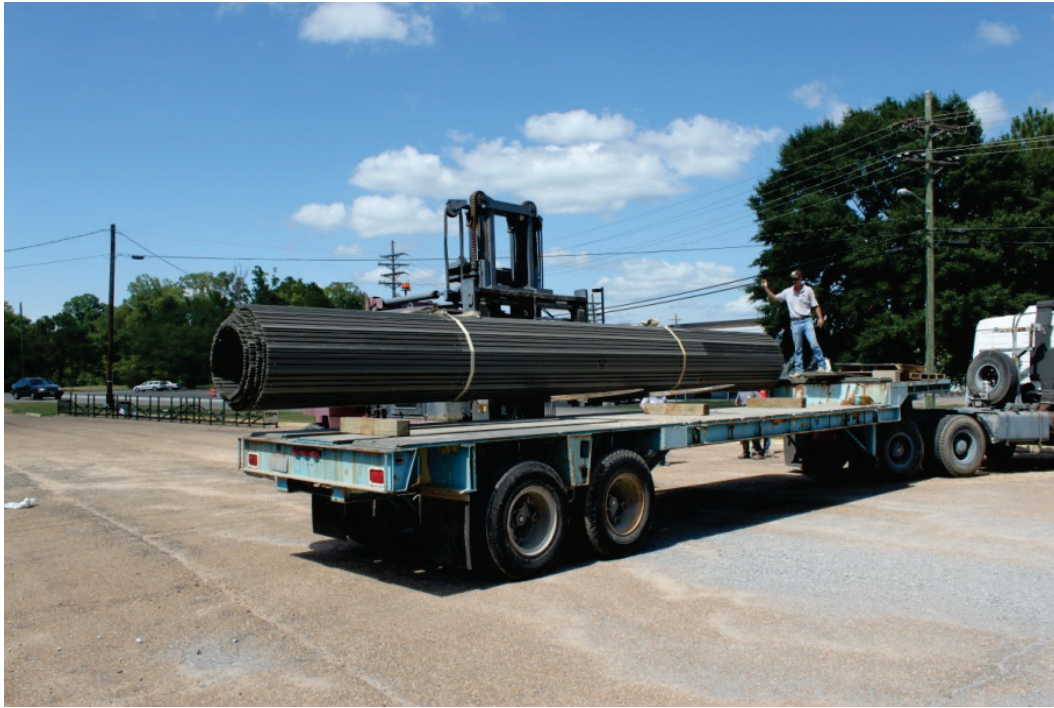
Figure 16. Loading mat expense onto a flatbed trailer.

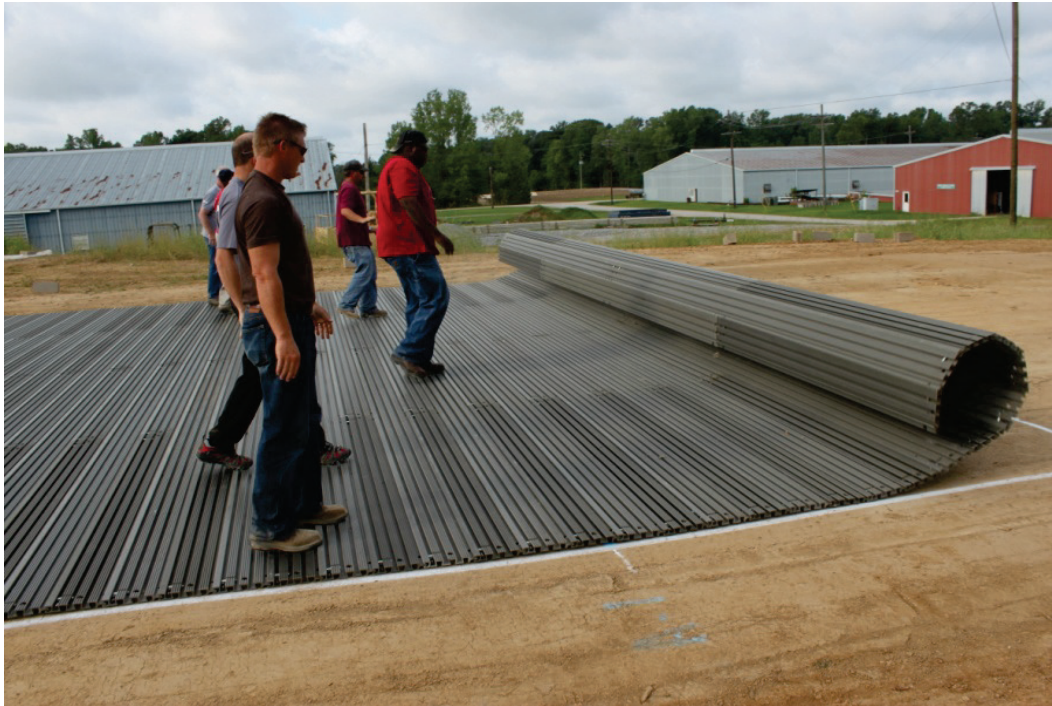
Figure 18. Unrolling MLC-70 matting on prepared test section.

Once the matting system arrived at the test site, it was unloaded and installed on the subgrade. The 30-ft-wide by 40-ft-long section was pushed by six men and was unrolled in approximately 5 sec. Figures 17 and 18 show how the mat was pushed and unrolled. Once unrolled, the mat was stretched to ensure all the slack had been removed from the joints and lead weights were placed along the edges to limit movement of the system. AM2 matting was placed at each end of the test section to create stable platforms for the load cart for entering and exiting the test area. The completed test section prior to trafficking is shown in Figure 19.

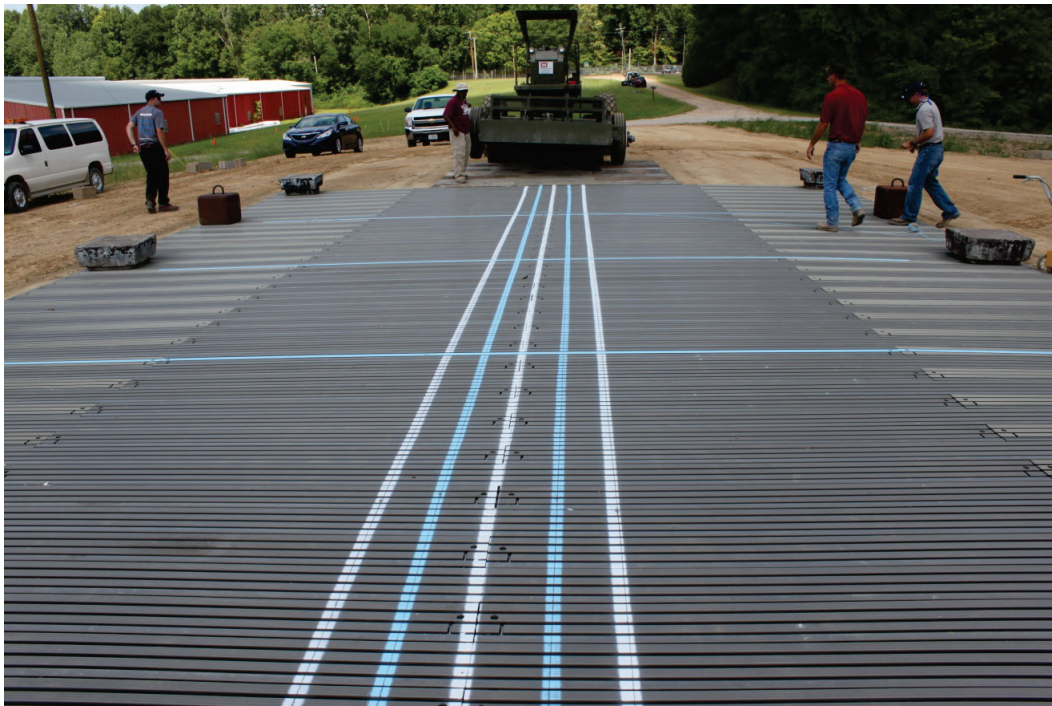
Figure 19. Final assembled F-15E traffic area with AM2 ramps.

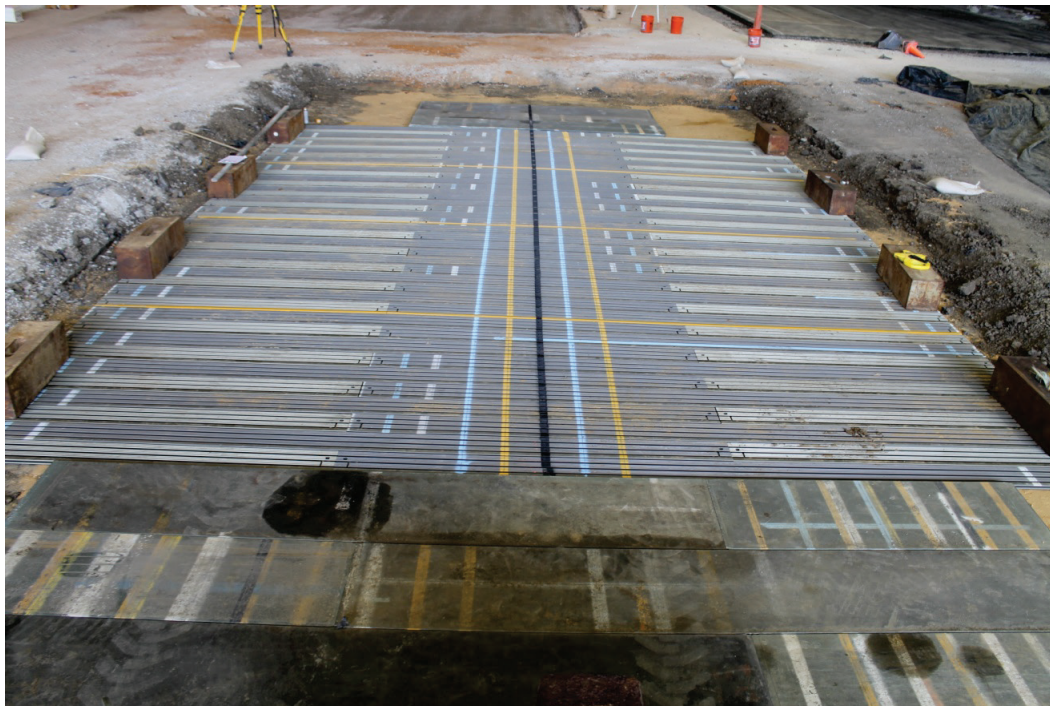
Figure 20. Final assembled 25 CBR test section.

The MLC-70 panels were installed in the same way as described for the 25-50 CBR test section above. AM2 ramps were installed at the north and south ends of the MLC-70 matting to facilitate the F-15E load cart movements. Steel weights were placed along the edges of the matting to limit movement of the test item and to mimic the effect of a larger expanse of matting. The final assembled test section is shown in Figure 20.

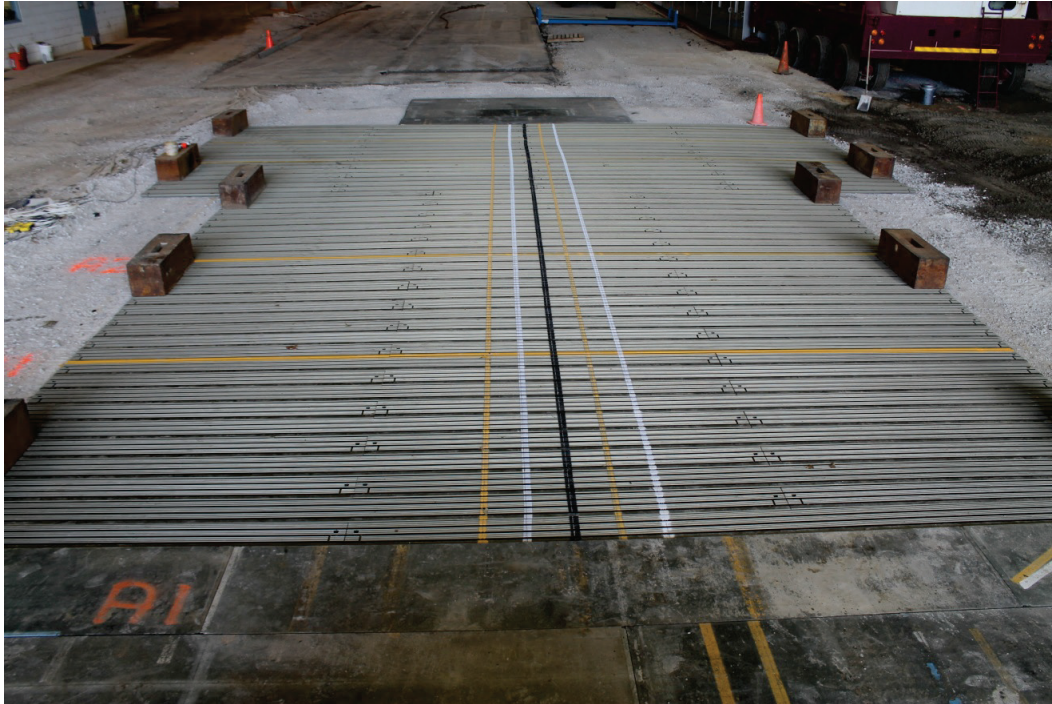
Figure 21. Final assembled 100 CBR section.

arrangements simultaneously. AM2 ramps were installed at the north and south ends of the MLC-70 matting to facilitate the F-15 load cart movements. Steel weights were placed along the edges of the matting to limit movement of the test item and to mimic the effect of a larger expanse of matting. The final assembled test section is shown in Figure 21.

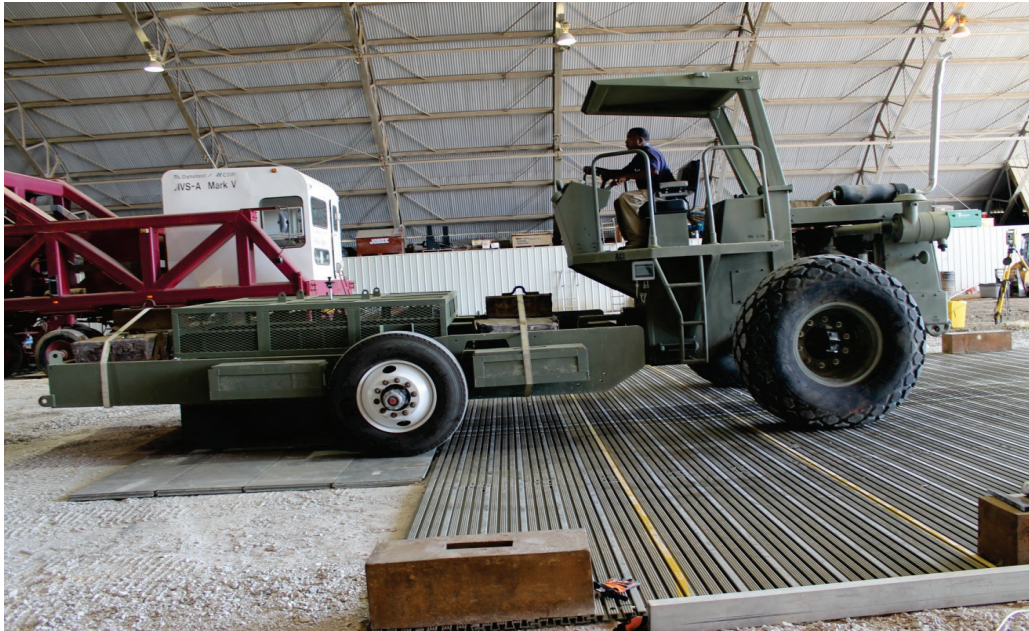
Figure 24. F-15 test load cart.

A specially designed single-wheel load cart was used to simulate F-15E aircraft traffic. The load cart was equipped with a 36 in.-by-11 in., 30-ply tire inflated to 325 lbf/in.<sup>2</sup> and loaded such that the test wheel was supporting 35,235 lb. The F-15E load cart was equipped with an outrigger wheel to prevent overturning and was powered by a steel wheel compactor engine as shown in Figure 24.

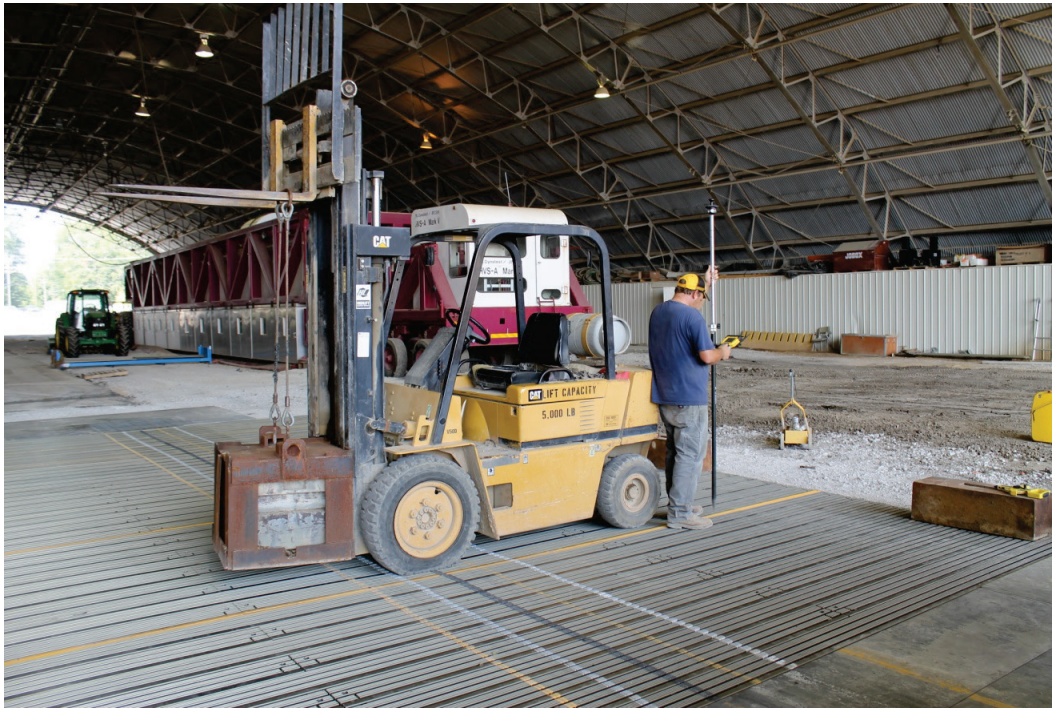
Figure 27. Typical loaded cross-section data collection.

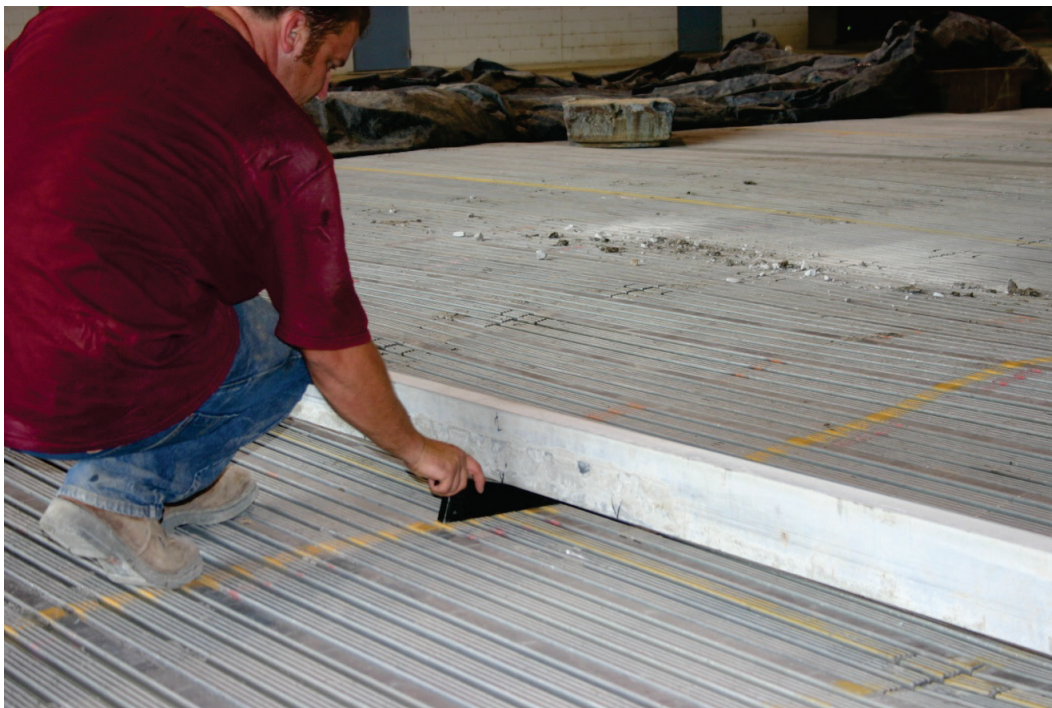
Figure 28. Typical unloaded rut depth measurements.

“centerline profiles” in this report. Rut depths were measured on each data collection line with an aluminum straightedge and a ruler. Measurements were taken at the centerline and at one foot east and west of the centerline. Elastic deflection measurements were recorded along the centerline by mounting a prism on the load cart above the test wheel and continuously recording the change in elevation while trafficking. The amount of mat damage and the mode of failure were recorded during the traffic phase.

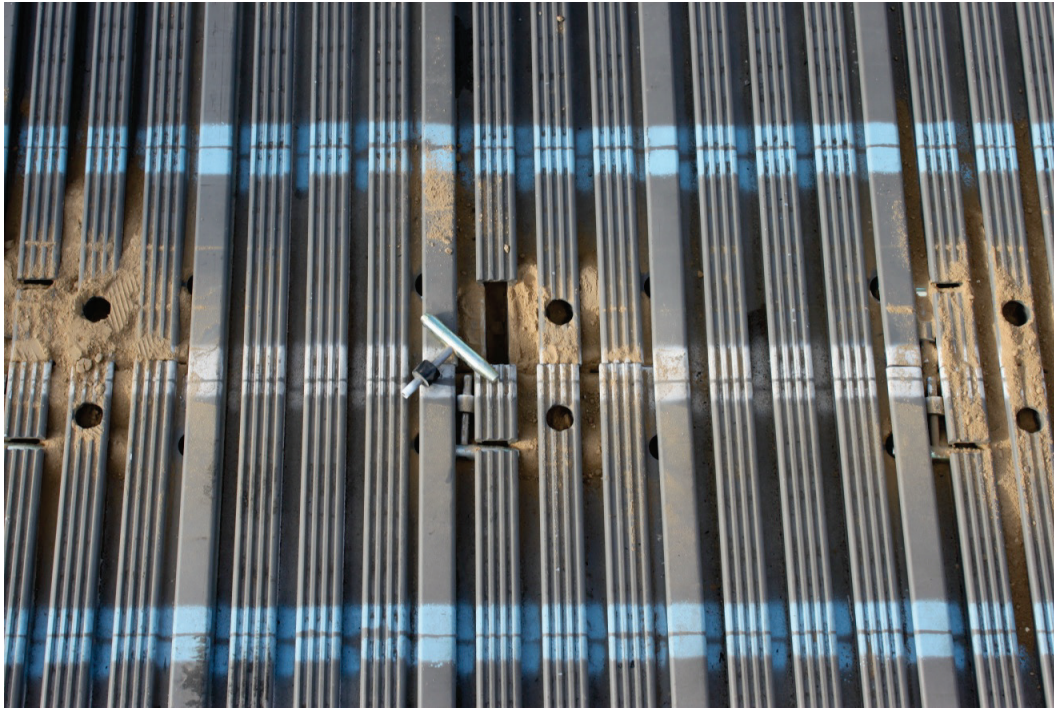
Figure 29. Broken mat panel after 112 passes on the 25-50 CBR section.

Trafficking began June 27, 2011, on the 25-50 CBR test section. After 16 passes, deformation was noted along the centerline of the panels near data collection line A1. Deformation continued to increase with each pass of the F-15E load cart. After 112 passes, a small section of matting between the shoot bolt and the end of a mat panel in the 20th panel row broke free as shown in Figure 29. The loaded deformation along A1 and A2 had reached 1.92 in. and 1.59 in., respectively, and therefore exceeded the failure limit. Also, slight corner curls were noted along centerline panel joints from rows 1 through 30. Once 240 passes had been completed, another piece of matting between the shoot bolt and panel end broke free from a mat on row 14, and the deformation along the first 15 ft of the test section was nearly 3 in. This large deformation caused a significant bow wave to form that resulted in instability in the load cart, as shown in Figure 30. The loaded deformation along A3 had reached 1.38 in., which also exceeded the failure limit. The subgrade material had worked its way through the mat joints and covered the mat section in the wheel path, as shown in Figure 31. Because of the instability and threat of a tire hazard by pinching the tire between the panel joints, traffic was stopped over the first 15 ft of the test section.

Only two panels were noted to have broken pieces of the upper section of the mat between the free end and the shoot bolt closest to the traffic centerline. This damage was determined to be a function of subgrade deformation and not solely mat panel fatigue failure. As the subgrade deformation became greater than the failure criterion, the two free panel ends along the centerline began to contact each other and were forced to rotate downward under the test load. The downward force was transferred into the two panels since there was little subgrade support underneath. A crack was incubated and then propagated under low cycle fatigue, until the mat piece broke free from the panel and instantly relieved the stress from its partner piece on the opposite side of the centerline. These two mat breaks were considered failure; however, the 10% mat breakage failure criterion was not reached during the evaluation.

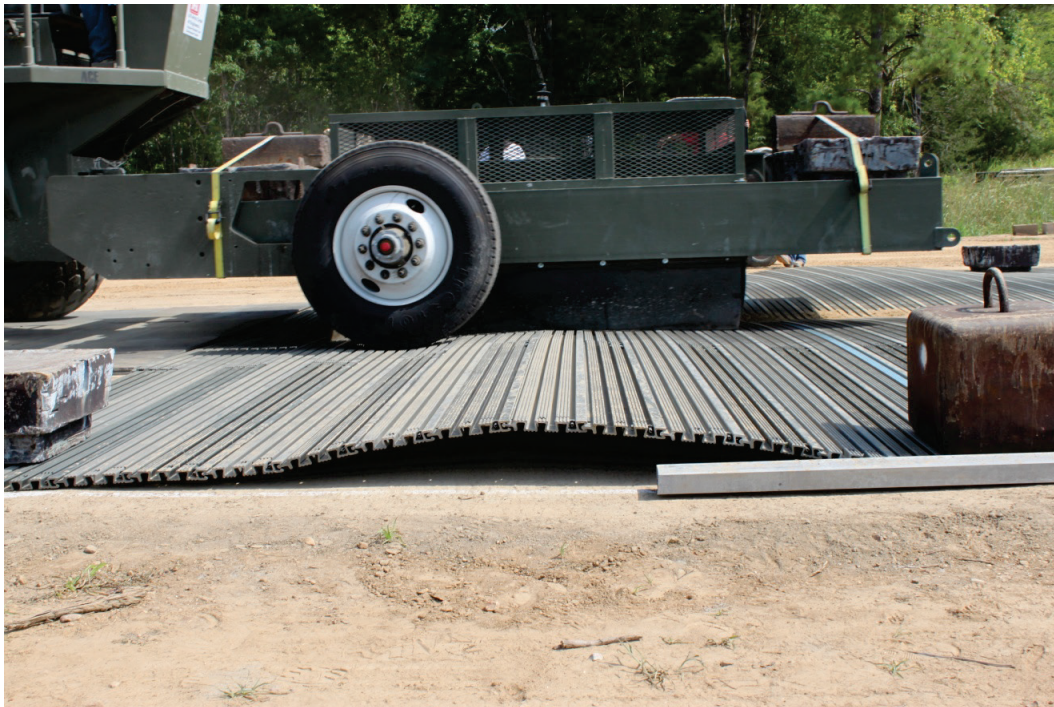
Figure 30. Excessive rutting and bow-wave formation after 240 passes near A1 on the 25-50 CBR section.

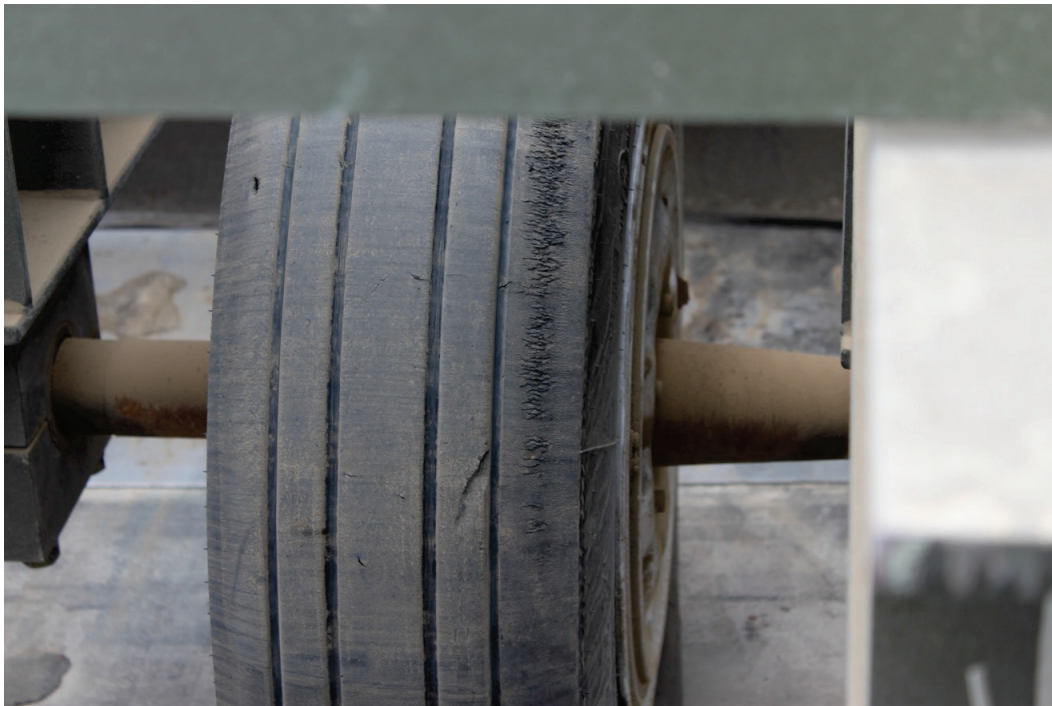
Figure 32. Tire damage after trafficking 25-50 CBR test section.

Traffic was resumed on the remaining section. After 496 passes, trafficking was stopped after tire damage was noted on the F-15E test wheel, as shown in Figure 32. At this time, the permanent deformation along lines A1, A2, and A3 ranged from 1.5 to 3.0 in., and therefore exceeded the 1.25 in. deformation limit over the entire length of the test section. No further traffic was applied. A summary of the panel damage and deformation is presented in Table 7.

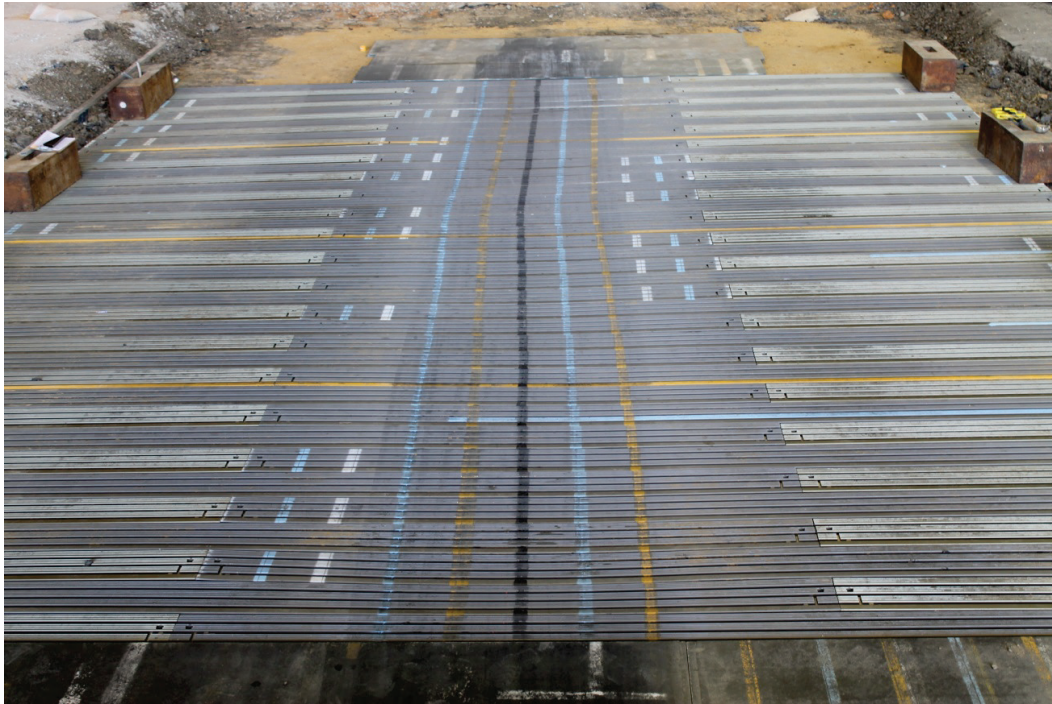
Figure 44. Final condition of 25 CBR F-15E test section after 2,032 passes.

Visual inspection of the MLC-70 panels at the conclusion of the 25 CBR F-15E traffic test revealed no damage other than about 3/4 in. of dishing. Therefore, the system was able to sustain 2,032 simulated F-15E passes without breaking or becoming a tire hazard, even though the panels were deformed. The MLC-70 mat system was not stiff enough to prevent subgrade deformation from occurring. As the subgrade deformed, an air gap began to form between the bottom surface of the mats and the top of the subgrade. Eventually the size of the air gap increased until the strain in the mat exceeded its elastic limit. Once the elastic limit was exceeded, the mat began to yield and plastically deform. Nearly all of the panels in the wheel path had some degree of dishing; however, the dishing did not cause

tire hazards nor prevent further operations from occurring and was not counted as mat breakage in terms of the failure criteria. Mat panel dishing is accounted for in the subgrade deformation failure criterion.
